2018 ASME/KEPIC Joint Workshop

Status of Repair Technology Development for Damaged Clad in RPV

Kyung Ho Lee KHNP Central Research Institute

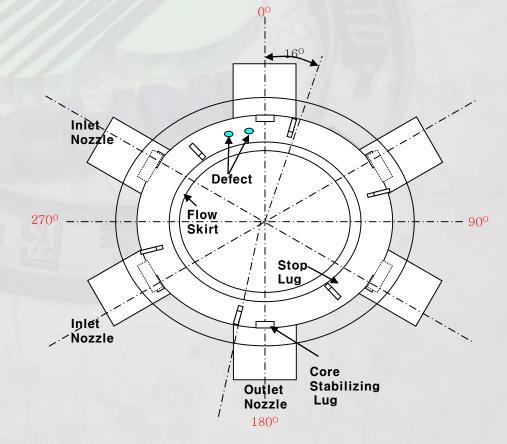
> Confirm the damaged clad of RPV for Hanbit unit 5 by falling Thermal Sleeve ('03. 4)

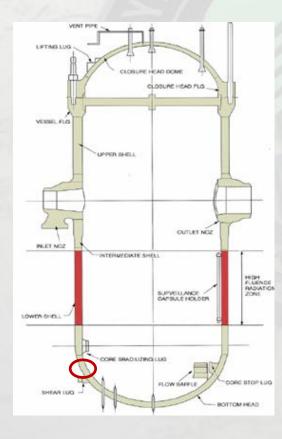
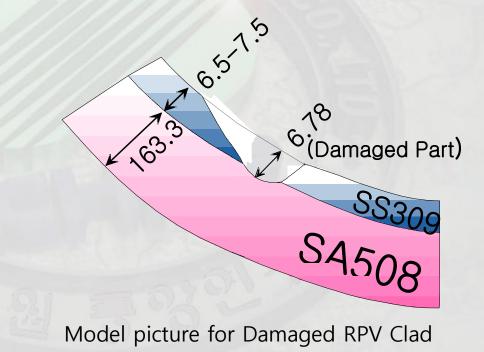
Base metal exposed to cooling water

* Average corrosion rate : 0.1 mm/year

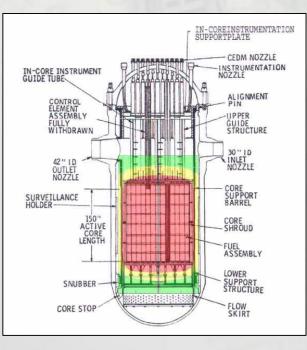
- Red -Zone-He generation greater than 10 appm (not weldable with current welding processes)
- Yellow- Zone-He generation greater than 0.1 appm and less than 10 appm (weldable with heat input control)
- Green -Zone-He generation less than 0.1 appm (No special process control is needed)

He concentrations around damaged area : 0.01 appm * Welding is available regardless of heat input effects (No He embrittlement)

- Computation of Neutron doses for RPV clad [EPRI, MRP-346]
 - Computation Code : RAPTOR-M3G / ALPAN-VII.0
 - Considered values : operation duration(20, 40, 60 EFPY), initial Boron concentration(1, 10, 50, 75 wppm), Ni contents 12%

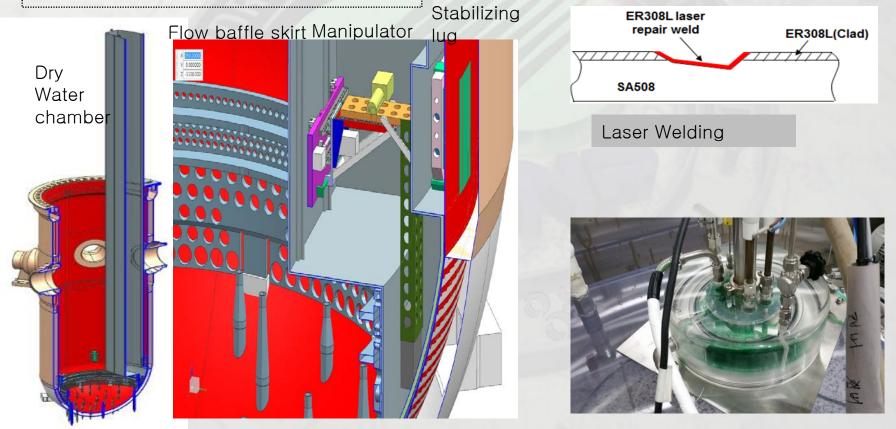
Ni-plating cell

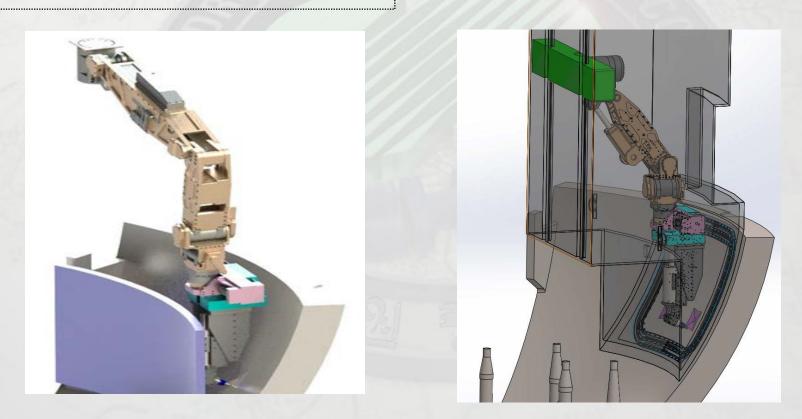
Articulated robot arm inside of dry water chamber

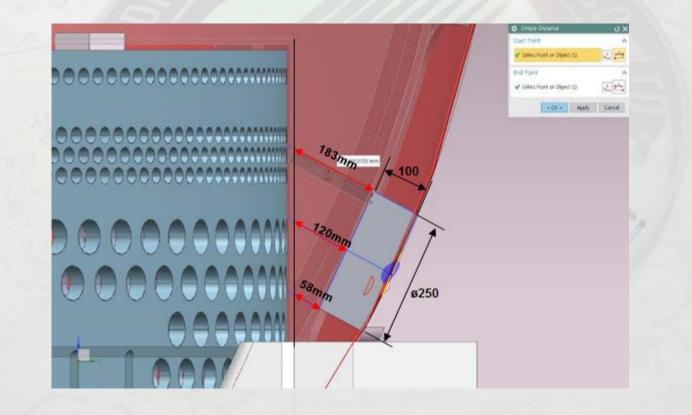
Ni plating chamber will be installed around damaged area

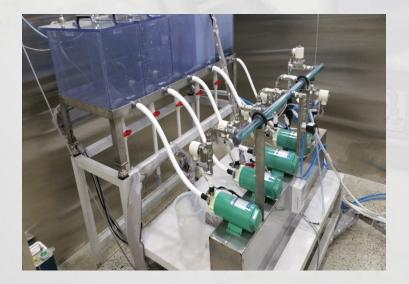
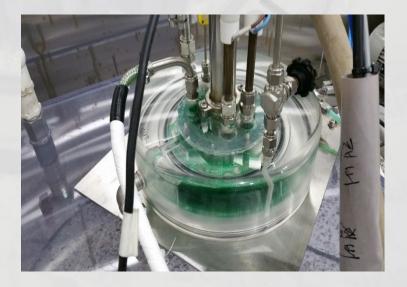
- Correlation analysis among Ni plating factors
 - Pre-Ni plating thickness(5 μm) , current density(100 mA/cm²), Niplating temp.(60 ° C)
- Ni plating tests (Laboratory scale, 30 hours continuous test)

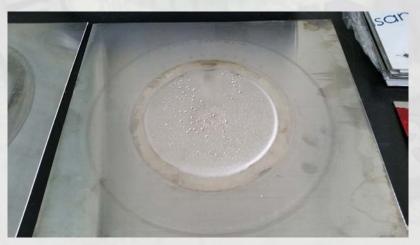
- The initial tests have not been satisfied as below figure. There was a few pits happened.
- Currently, we have changed Ni plating chamber structure to improve the circulation of Ni liquid solution.

• Need to find optimal deposit thickness to protect base metal of RPV.
